Dianna Pope Natural Area

Site Conservation Plan

2017 - 2022

East Multnomah
Soil and Water Conservation District

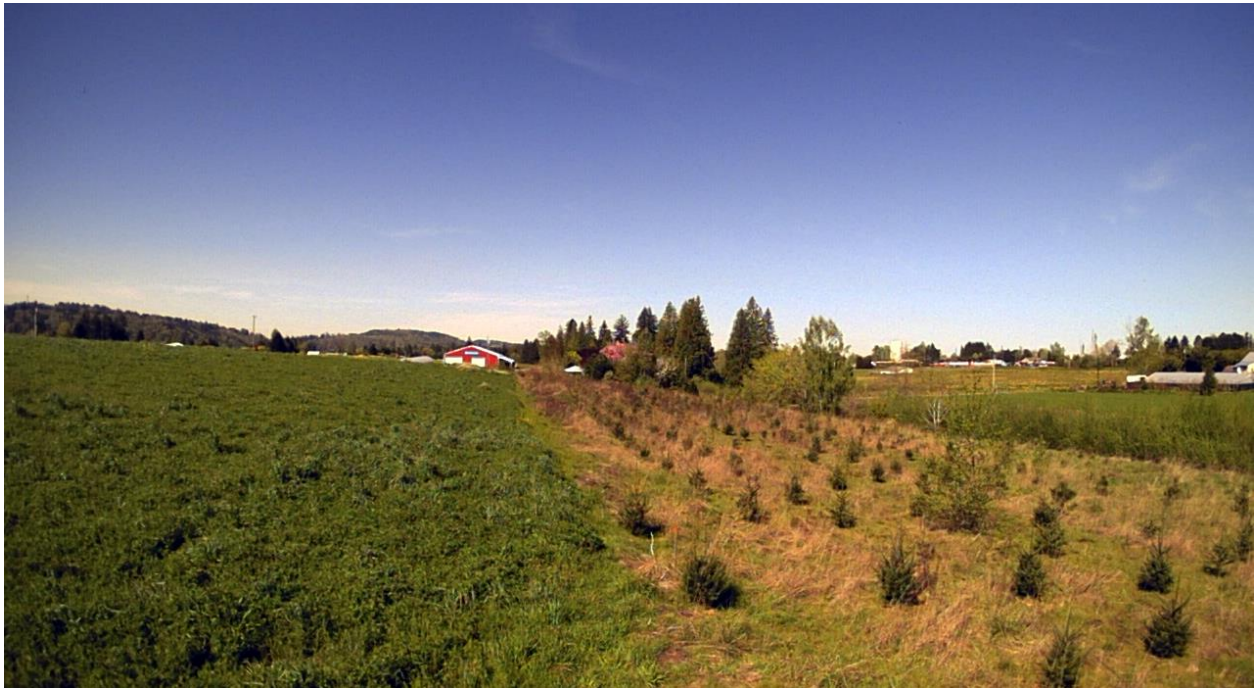
Figure 5: Photo of Dianna Pope Natural Area from Near Eastern Boundary

Note lack of existing canopy cover in East Unit in foreground and increasing canopy cover moving towards the mature, coniferous trees in background denoting the West Unit.

The vegetation in the Central Unit is in a much poorer condition. Dense vegetation, primarily willow, exists in a band along the creek ranging from 15 to 30 feet from each bank and a few, mature Douglas fir and western red cedar are found on the east end of this unit (see Figure 7). Due to previous farming operations, however, this unit is lacking in canopy cover. An extremely dense stand of black cottonwood and red alder has also grown on the south side of the creek in this unit since EMSWCD purchased the property. EMSWCD has controlled invasive weeds in this unit and planted appropriate riparian species throughout. Plant communities installed include mixed coniferous/deciduous riparian forest, and scrub shrub wetland forest depending on soil, moisture, and light conditions. The ground cover where the plantings have been installed is primarily composed of non-native grasses and forbs (see Figures 5, 6, and 7).

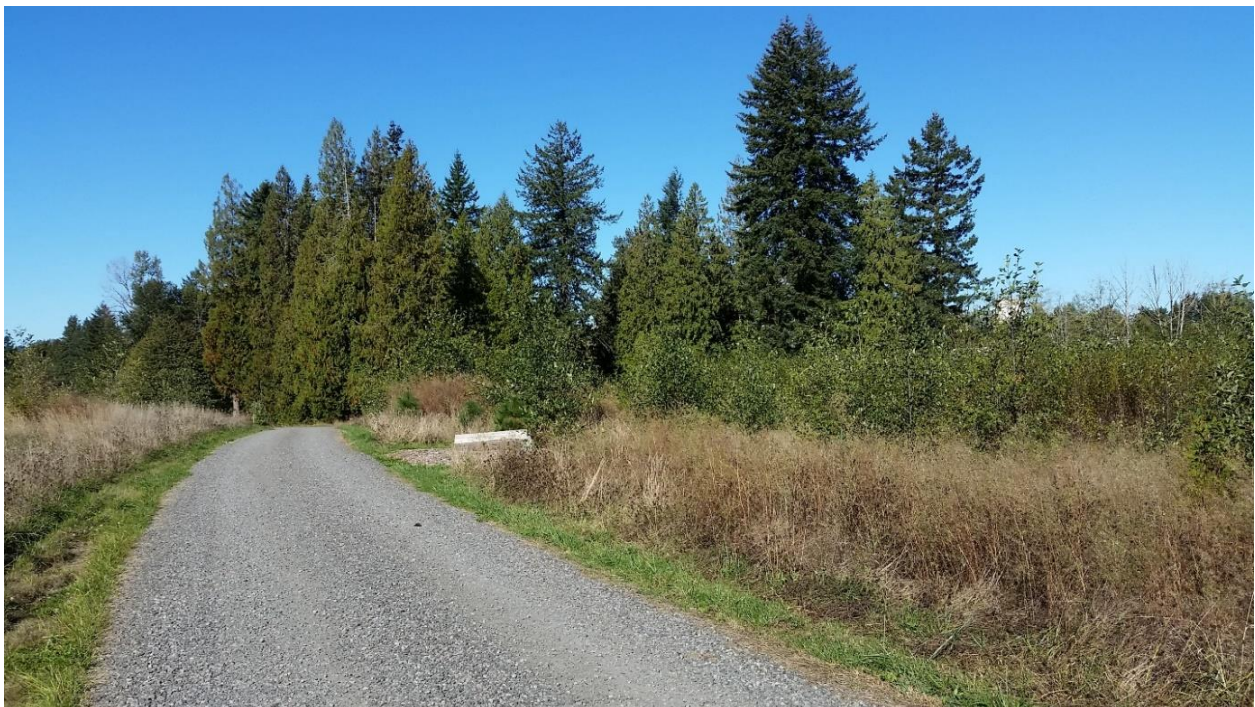
Figure 6: Current Conditions in Central and West Unit

Central Unit in Foreground, West Unit in background, denoted by mature conifers.

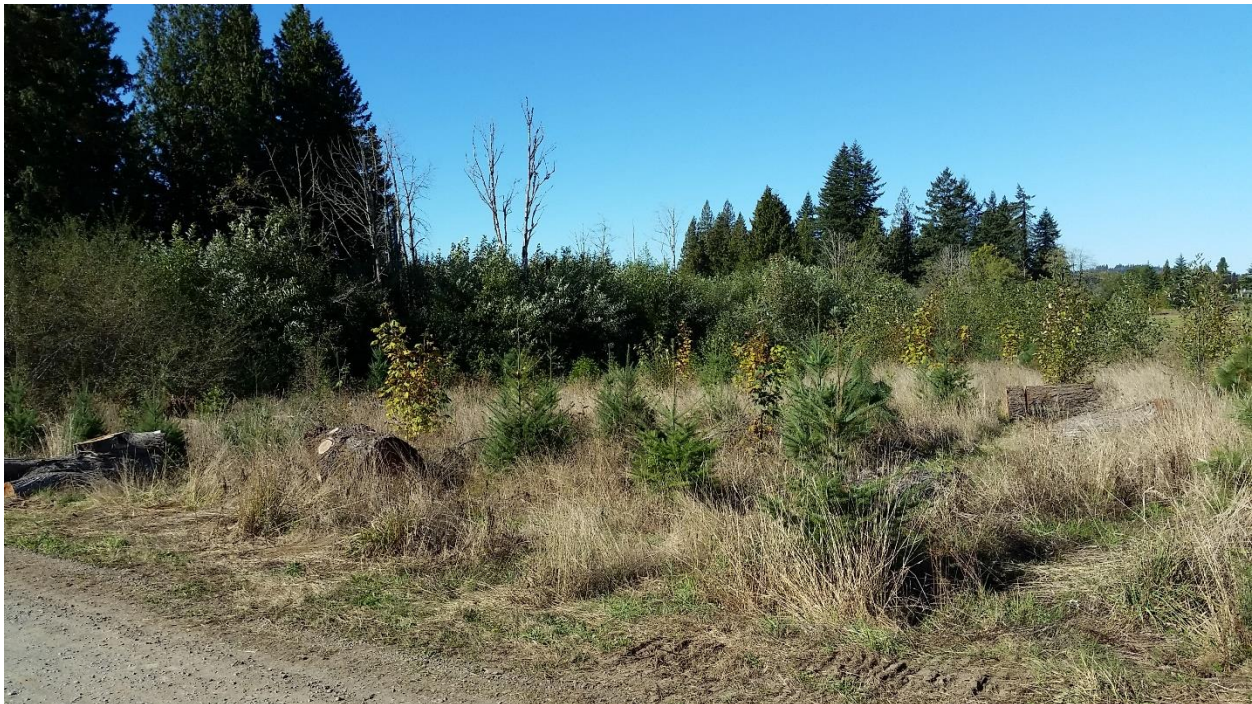
Figure 7: Current Conditions in Central and West Unit

Central Unit in foreground denoted by young plantings, snags, and willows, West Unit in background, center left of photo, denoted by dense, mature conifers.

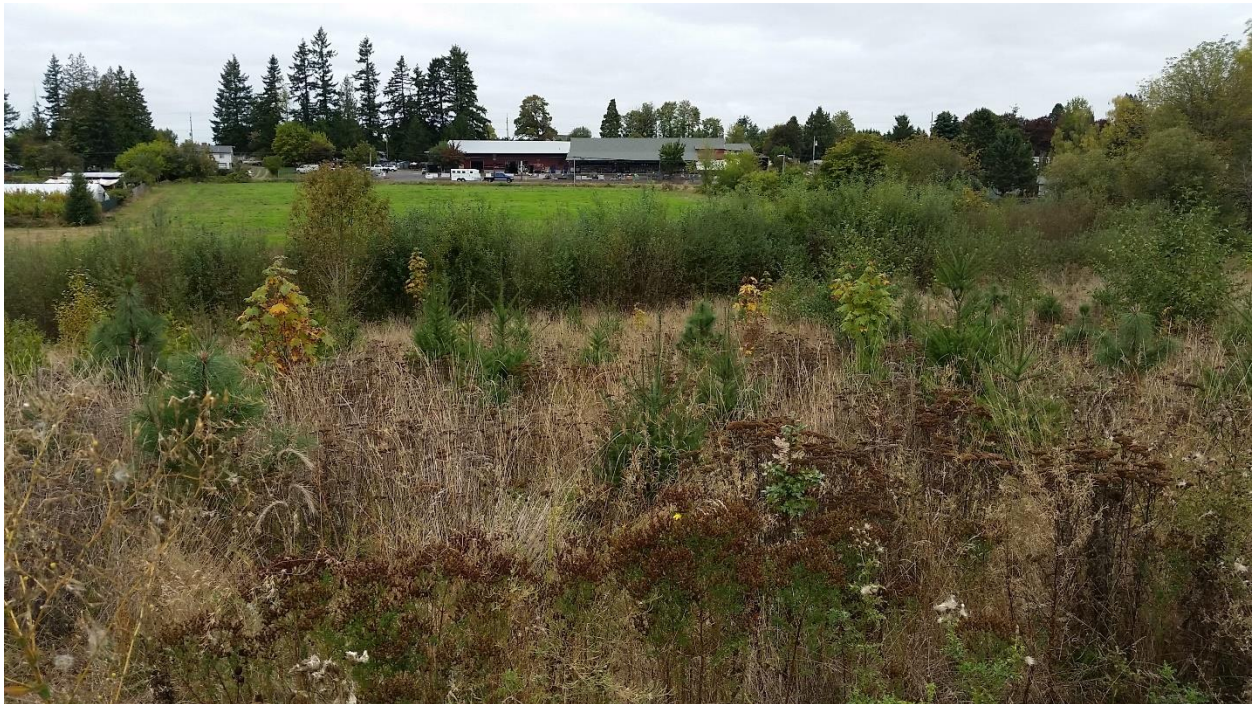
Figure 8: Current Conditions in East Unit

Note band of willow/shrub scrub forest along creek near center of photo.

The vegetation in the East Unit is the most degraded. There are very few mature trees in this unit. EMSWCD has controlled invasive weeds in this unit and planted appropriate riparian species throughout. Plant communities installed include mixed coniferous/deciduous riparian forest and scrub shrub wetland forest comprised predominately of dense willow planted between ten and 25 feet from the banks (see Figure 8). The ground cover where the plantings have been installed is primarily composed of non-native grasses and forbs. A native ground cover mix was also installed to prevent erosion and further weed recruitment after large amounts of Canada thistle were controlled during the initial site preparation of this unit (see Appendix 2 for details). Compared to other units of the DPNA, this unit will make the greatest transition to mature riparian forest and represents the largest potential for increase in ecosystem function.

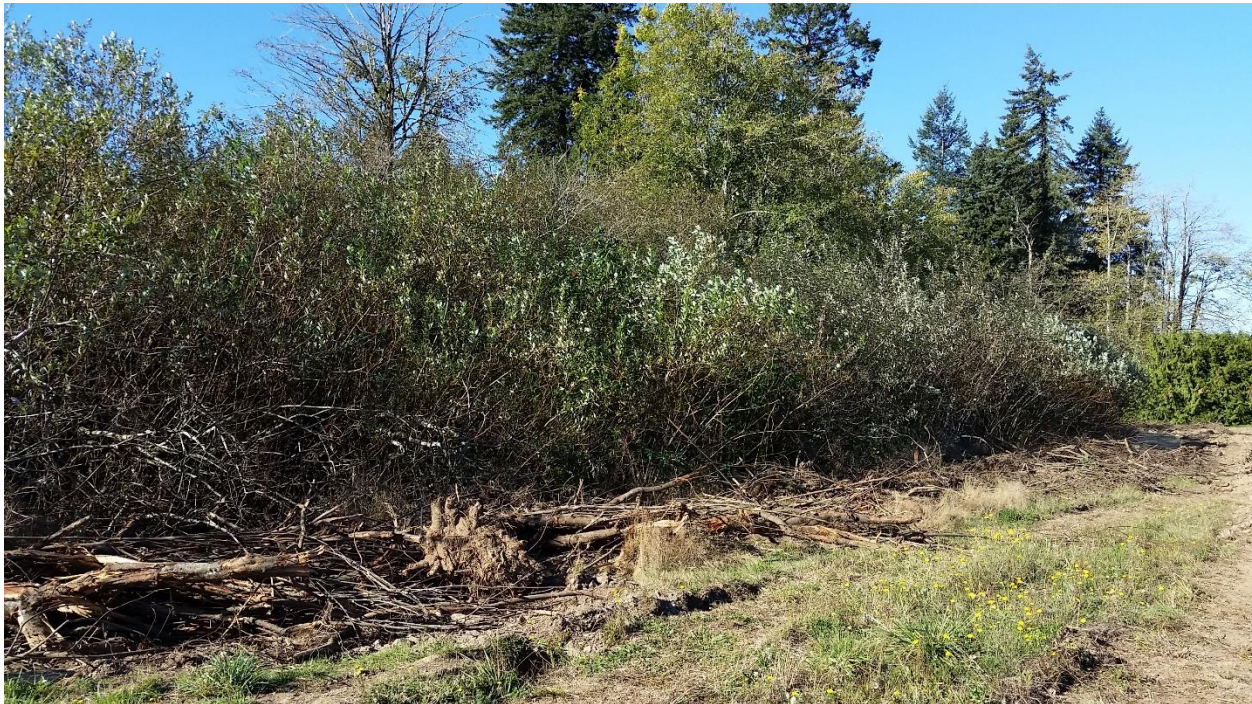
Figure 9: Example of Dense Willow Band Found Along Majority of Stream Length

Willow flycatchers, a state listed sensitive species and federally listed species of concern, likely occur within the DPNA. They are commonly seen or heard on other EMSWCD riparian restoration sites but have not yet been observed in the DPNA. Willow flycatchers are dependent upon dense, continuous, shrubby riparian habitat, especially willows, and conservation actions for this species include improving and/or increasing this type of habitat. This type of habitat has been greatly increased and enhanced within the DPNA as over 2750 willows and associated shrub-scrub wetland species such as red osier dogwood and Douglas spiraea have been planted into areas previously dominated by invasive reed canary grass. This has created a continuous band of shrubby, willow dominated vegetation beginning at the eastern boundary of the DPNA and extending for about 0.33 miles of stream, or a little over 80% of the stream length, within the DPNA (see Figure 9). This band extends around 10-25 feet from both banks along this length.

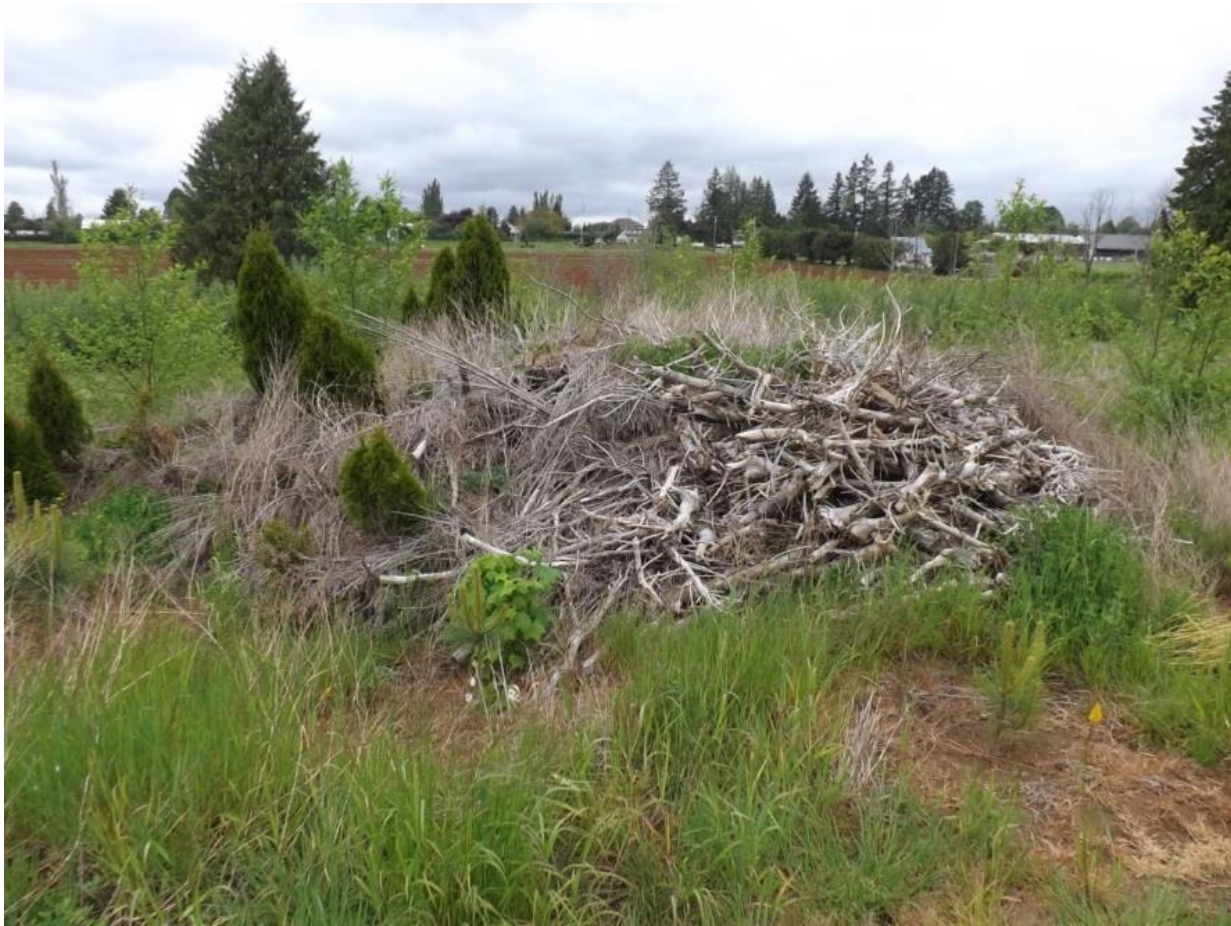
Figure 10: Debris Piles for Pollinator Nesting

Pollinator conservation is a large focus on Headwaters Farm outside of the DPNA boundaries. EMSWCD partnered with The Xerces Society to create pollinator meadows. Also, additional pollinator meadows and hedgerows have been and will continue to be planted by EMSWCD staff. Although many of the plants installed in the DPNA provide pollinator forage, the main pollinator components within the DPNA are brush and dirt piles comprised of previous bulldozed nursery stock located on the edges of the DPNA (see Figure 10). These piles provide critical nesting habitat for native pollinators lacking in most "clean" farm systems. These piles also provide refugia for other insects, birds, mammals, and amphibians. Quail have been observed regularly using the piles for cover.
