Dianna Pope Natural Area

Site Conservation Plan

Version 5.0

East Multnomah
Soil and Water Conservation District

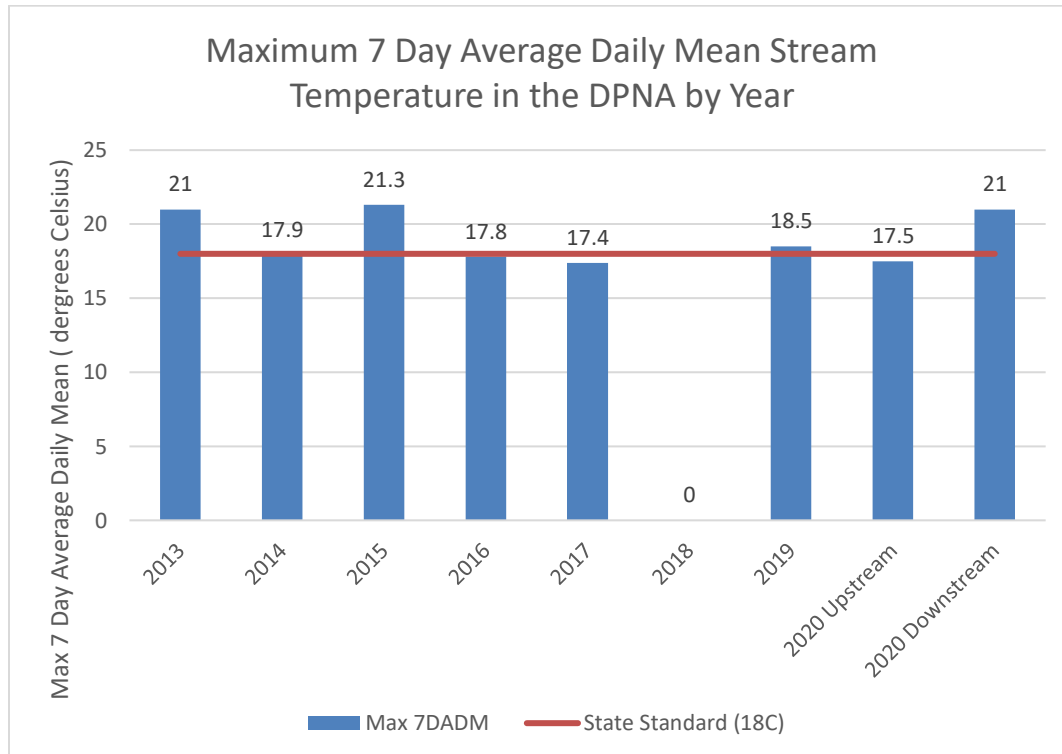
Figure 5: Graph of Maximum Seven Day Average Daily Mean Stream Temperature by Year

EMSWCD deploys a continuous water temperature data logger in the creek at this sampling location annually from April through October. This logger has been deployed each year beginning in 2013, although no data was collected in 2018. The data collected is compiled with continuous temperature data collected throughout the watershed by EMSWCD partners. The seven years of data collected from within the DPNA have revealed that stream water temperatures within the DPNA are relatively low when compared with temperatures found throughout the watershed. In 2020, with suspicion that the increasing beaver ponds were causing the stream to warm as it flows through the DPNA, a second temperature logger was deployed at the upstream end of the DPNA.

The temperature standard set forth by the Oregon Department of Environmental Quality for a stream identified as having salmon and trout rearing and migration is (not to exceed) 18 degrees Celsius (64.4 degrees Fahrenheit) measured as a seven-day average daily maximum (7DADM) temperature. The 7DADM temperature is a calculation of the average of the daily maximum temperatures from seven consecutive days made on a rolling basis. Although salmon or trout have not been found within the North Fork of Johnson Creek, the standard applies to the North Fork of Johnson Creek since both fish types are found in the main stem of Johnson Creek.

This is in line with recent studies by the City of Gresham into the effects of beaver dams on stream temperature. These studies have shown that beaver dams generally cool the stream in warm stream segments, but in cool, small, headwater streams, such as the North Fork of Johnson Creek as it flows through the DPNA, they generally warm the stream. Temperature will continue to be monitored at both locations in future years to see if this is a trend. Shade should return to the stream when the trees within the DPNA become larger, but this will likely take decades to be realized.

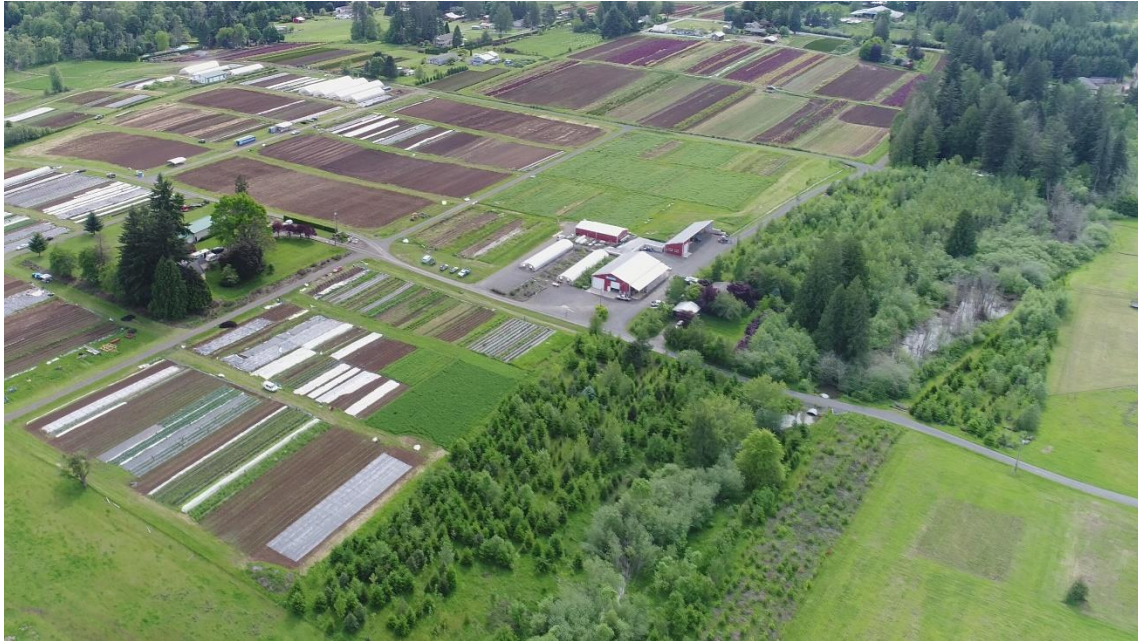
Figure 8: Aerial Photo of Dianna Pope Natural Area

Looking southwest. Nearly the entire DPNA can be seen at the right of the photo. East Unit in foreground moving towards West Unit in top right of photo where large conifers are seen. Headwaters Farm covers the majority of photo to left of the DPNA.

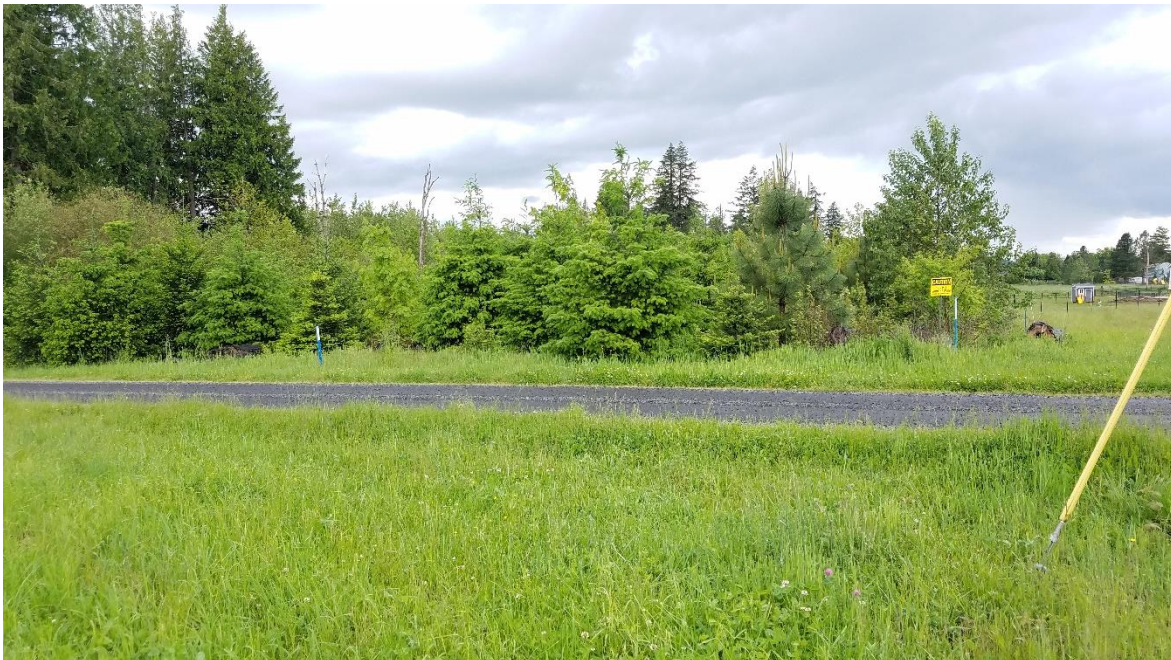
Figure 9: Current Conditions in Central Unit

Looking west at northeast corner of Central Unit from East Unit.

The vegetation in the Central Unit is in a much poorer condition, however, tree canopy is increasing rapidly. This is mainly due to an extremely dense stand of black cottonwood and red alder that has established naturally on the south side of the creek in an area that was used for potted plant production before EMSWCD owned the property. A few, mature Douglas fir and western red cedar are found on the east end of this unit (see Figures 8, 9, and 10). Dense vegetation, primarily willows, previously existed in a band along the creek ranging from 15 to 30 feet from each bank but has mostly been flooded and killed by inundation caused by beaver activity over the last few years. The dense cottonwood, alder, and willow currently cover nearly forty percent of this unit with young but rapidly increasing canopy cover. The black cottonwood and red alder in this unit are an average of 22 feet in height with an average DBH of 2 inches. EMSWCD has controlled invasive weeds in this unit and planted appropriate riparian species as needed. Plant communities installed include mixed coniferous/deciduous riparian forest, and scrub shrub wetland forest depending on soil, moisture, and light conditions. The ground cover is primarily composed of non-native grasses and forbs.

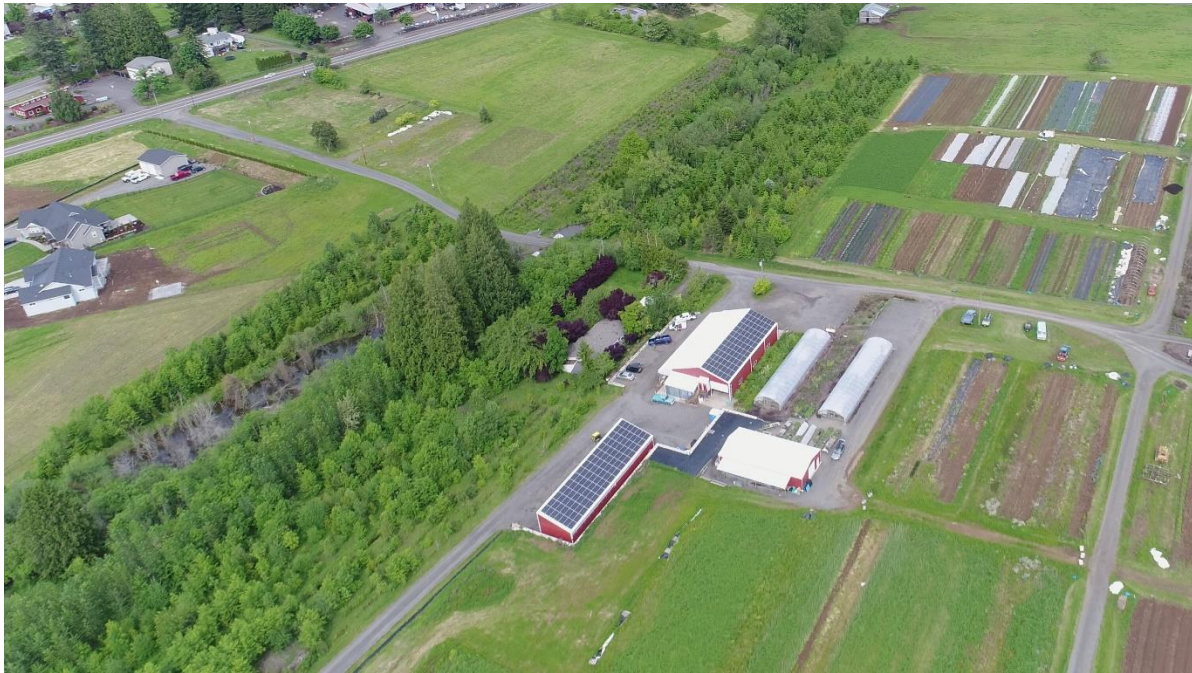
Figure 10: Current Conditions in Central and East Unit

Looking northeast. Central Unit in foreground with beaver pond and East Unit in background.

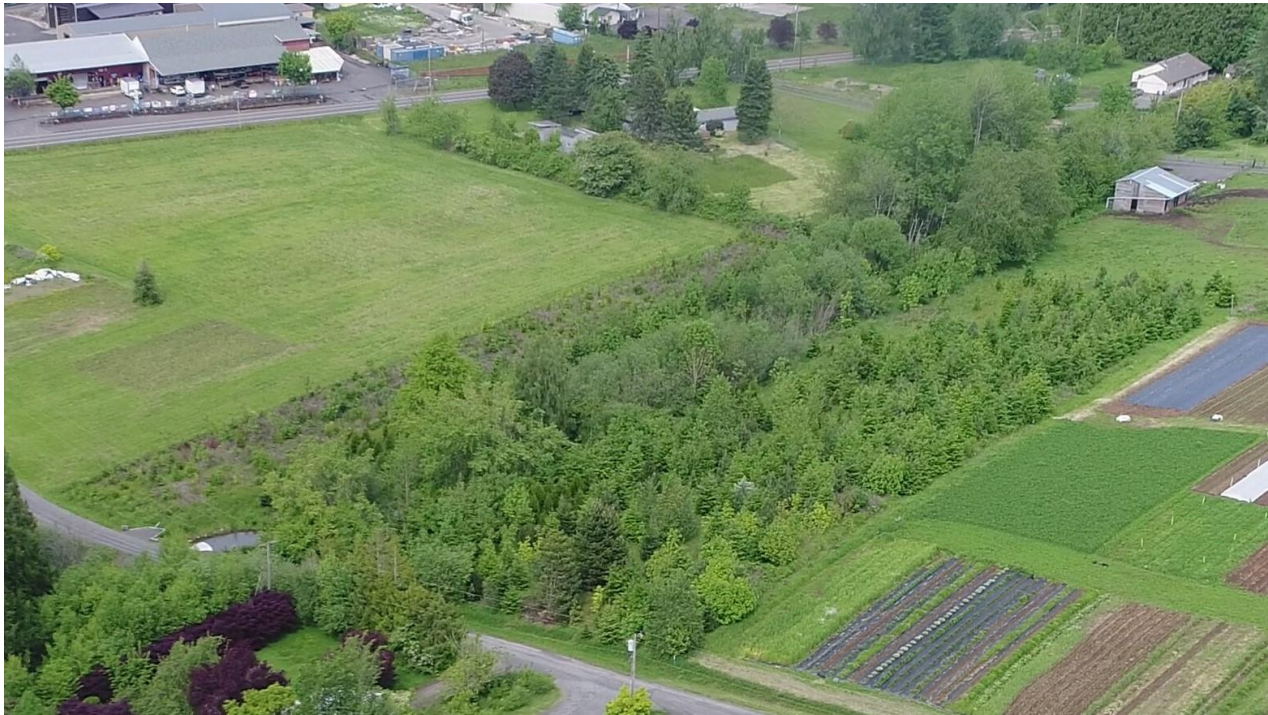
Figure 11: Current Conditions in East Unit

Looking northeast across East Unit.

The vegetation in the East Unit is the most degraded. There are very few mature trees in this unit and nearly the entire unit is dominated by young plantings installed by EMSWCD. EMSWCD has controlled invasive weeds in this unit and planted appropriate riparian species throughout. Plant communities installed include mixed coniferous/deciduous riparian forest and scrub shrub wetland forest comprised predominately of dense willow planted between ten and 25 feet from the banks (see Figure 11). The ground cover where the plantings have been installed is primarily composed of non-native grasses and forbs. A native ground cover mix was also installed to prevent erosion and further weed recruitment after large amounts of Canada thistle were controlled during the initial site preparation of this unit (see Appendix 2 for details). Compared to other units of the DPNA, this unit will make the greatest transition to mature riparian forest and represents the largest potential for increase in ecosystem function.

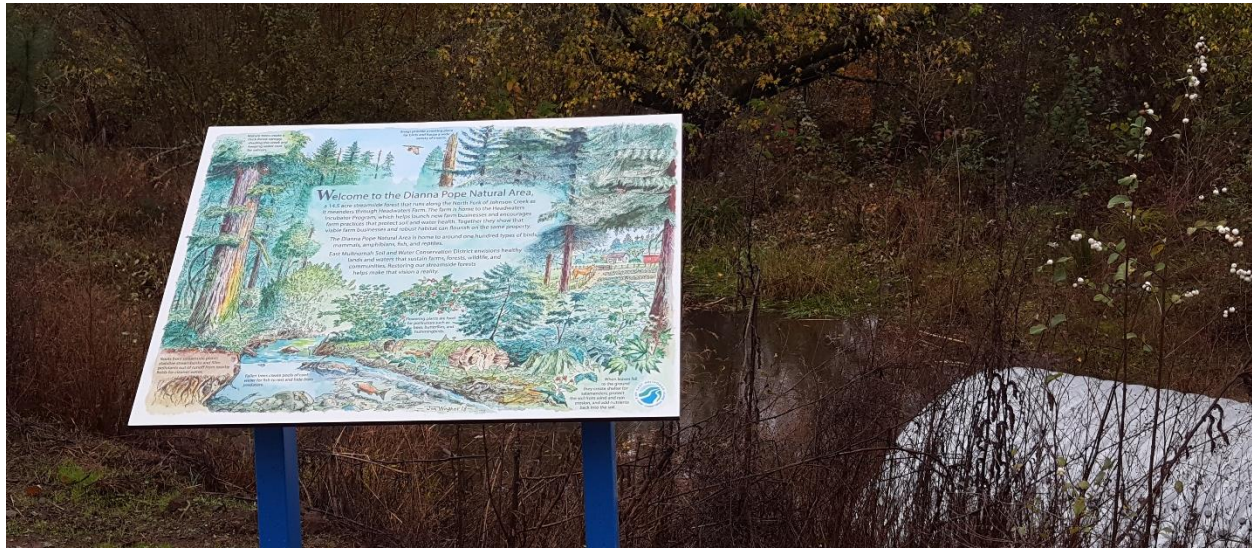
Figure 14: Interpretive Sign

An interpretive sign was installed in the West Unit of the DPNA adjacent to the main entrance road in 2018 (see Figure 14). The sign was designed and drawn by EMSWCD staff. An approximately 70 square foot gravel pad was developed for people to gather around the interpretive sign. The pad is at grade with the main entrance road and framed with wood to contain the gravel. Organized tours led by EMSWCD staff regularly stop on the road adjacent to the area of the interpretive sign to discuss the DPNA. The area around the interpretive sign allows a place for attendees of tours to gather off of the road, hence not blocking traffic on the road.

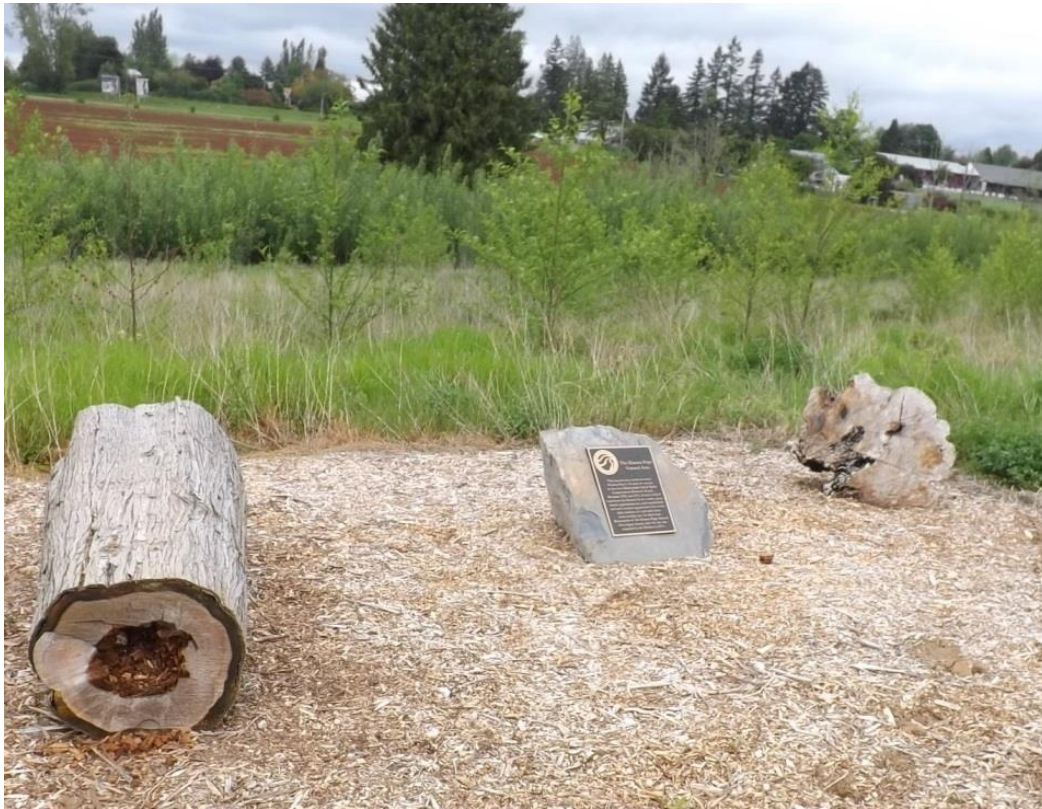
Figure 15: Dianna Pope Commemorative Area

A small wayside, on the south side of the Central Unit was constructed within the DPNA shortly after its designation. The wayside includes two logs that serve as benches and a plaque describing the reasons for designation of the DPNA as well as some information about Dianna Pope's service to EMSWCD (see Foreword). This area is approximately 400 square feet and is defined by a bed of mulch and the lack of trees and shrubs (see Figure 15). A western hemlock tree was planted adjacent to the plaque area by Dianna Pope at the ribbon cutting ceremony for the dedication of DPNA. In coordination with the DPNA Manager, the Headwaters Farm Program Manager will apply mulch to this area as needed to prevent bare ground and suppress weed growth as well as care for the western hemlock or replant if needed.
